Use of Forensic Engineering for Abandoned Building

Tomas U. Ganiron Jr.

This descriptive study focused on the forensic investigation of abandoned Government Service Insurance System (GSIS) building in Manila. The post-fire investigation was conducted on structural elements in order to ascertain their in situ residual strengths and also to provide data for use in future assessment. Tests were conducted on beams, columns, and slabs in both the affected and the unaffected parts of the buildings. From the results, visual examination of the fire-affected buildings revealed that the steel corrosion and concrete deterioration are the major factors that affected the stability and integrity of structural members of the abandoned GSIS building in Manila. There was a notable reduction in the in situ strengths of the fire-affected structural members when compared with the unaffected members. However, the abandoned GSIS building is still in serviceable condition in terms of its structural members

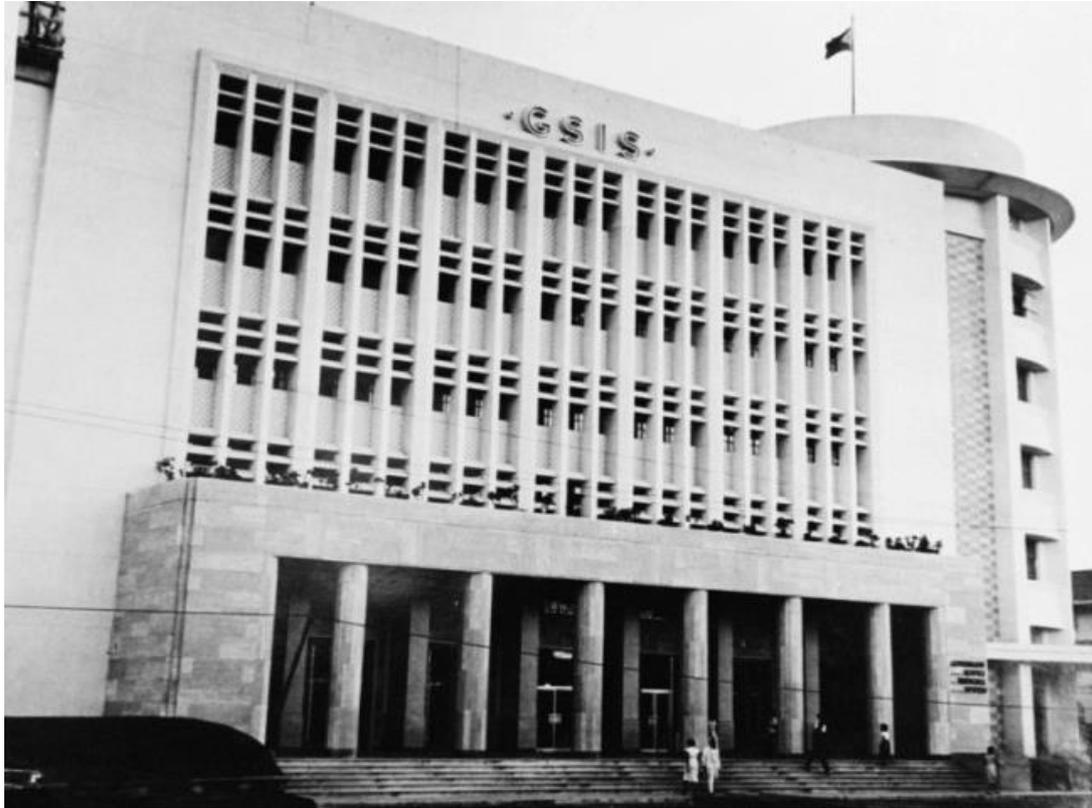
Figure 8. Old GSIS building in Arroceros Street, Manila

The external part of the GSIS building shows damage, one of the causes is deterioration due to time, broken window glasses collapsed small strip of concrete on the 5th floor, yet aside from the seemingly deteriorated facade the structure still stands firm. With the help of this study, the possible causes of its abandonment and the remedial measures may be discovered for a potential reuse of this structure.

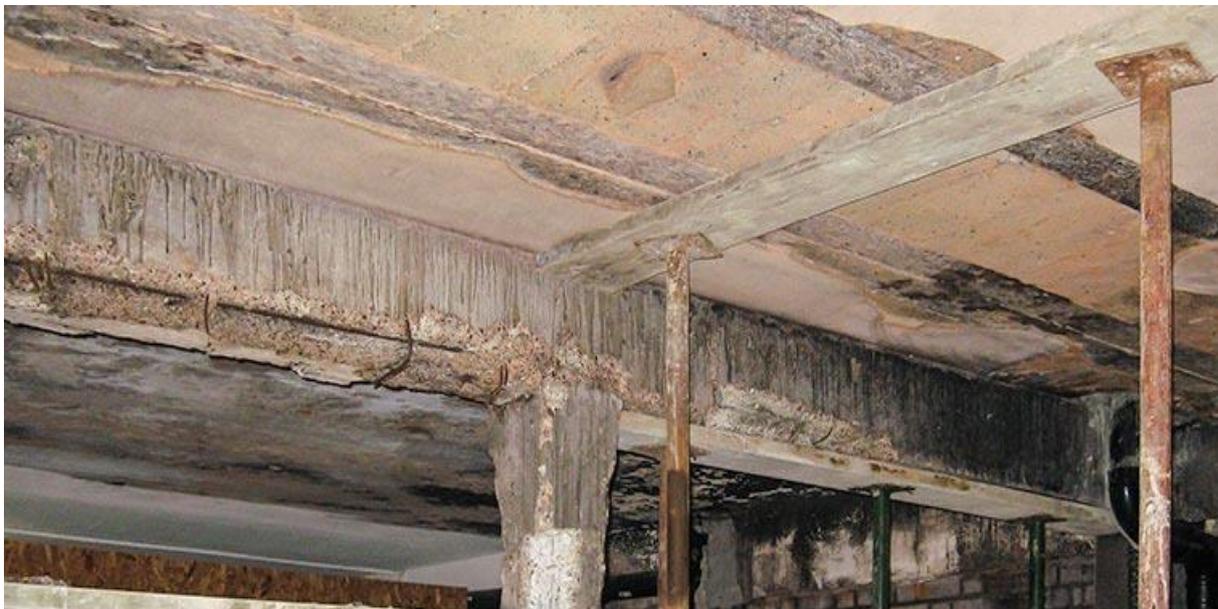
Figures 9. Spalling of concrete to beams and a column caused by fire

In addition, photographs of the various defects observed on the fire-affected concrete surface are also presented. Figures 9, 10 and 11 show various surface defects observed on some of the fire-affected members.

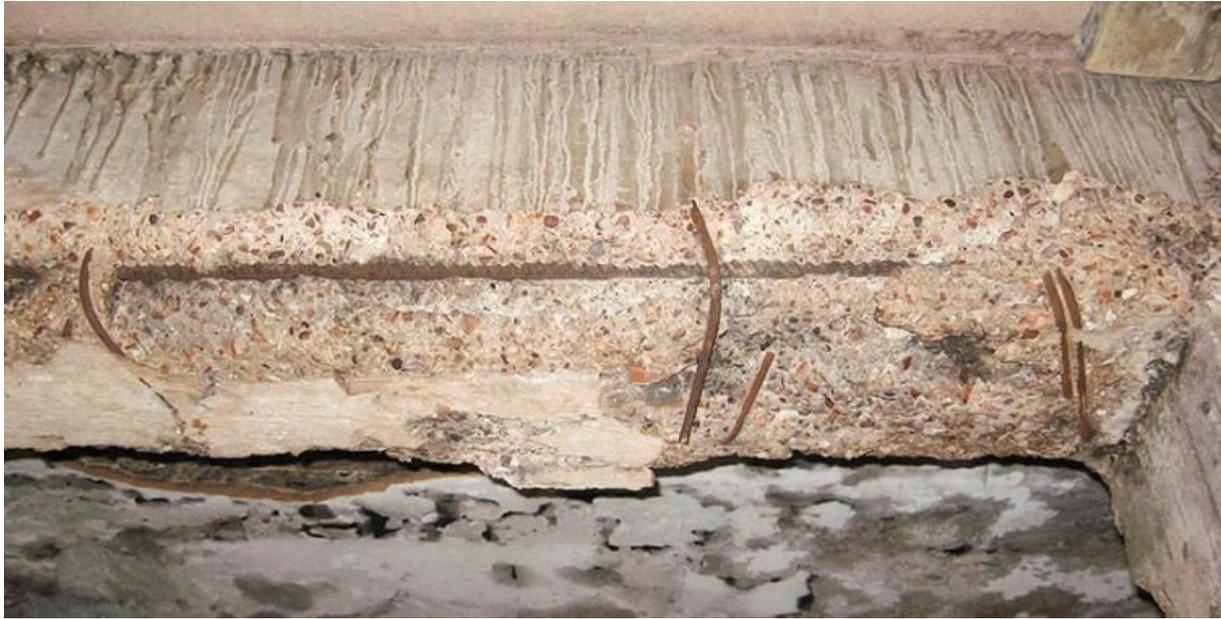
Figure 10. Reinforcement exposed on a beam soffit following a fire

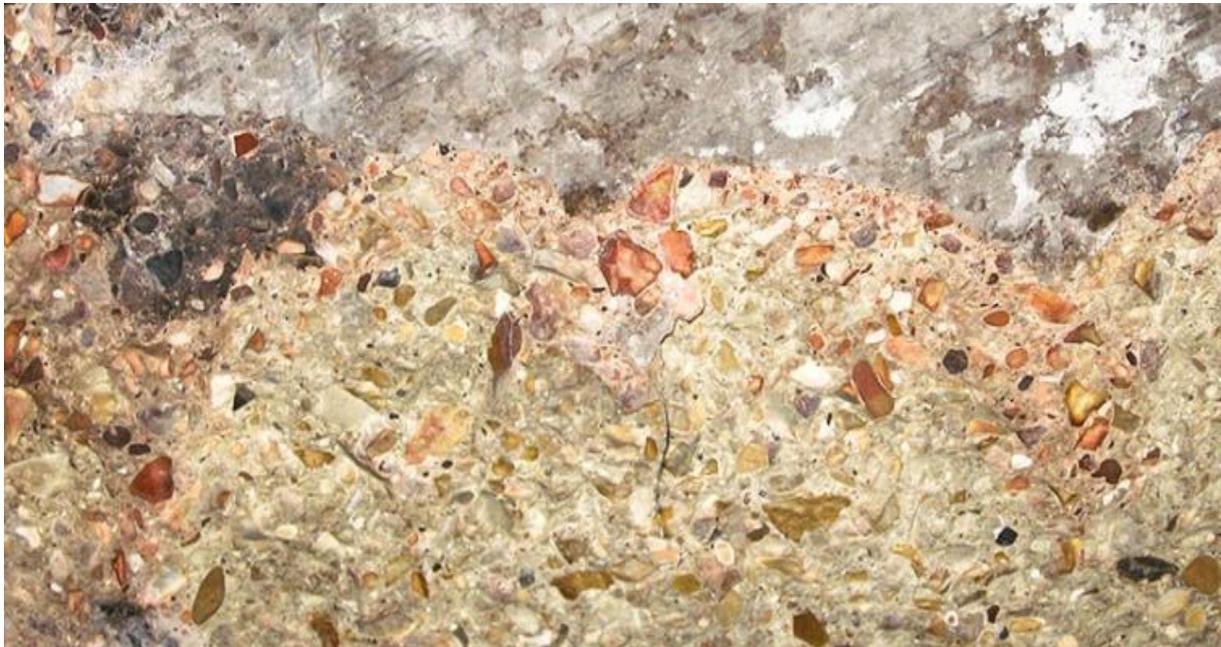
Figure 11. Concrete spalled from a slab soffit revealing pink/red discoloration
