World Scientific News

WSN 66 (2017) 97-108

Structural Failure of Buildings: Issues and Challenges

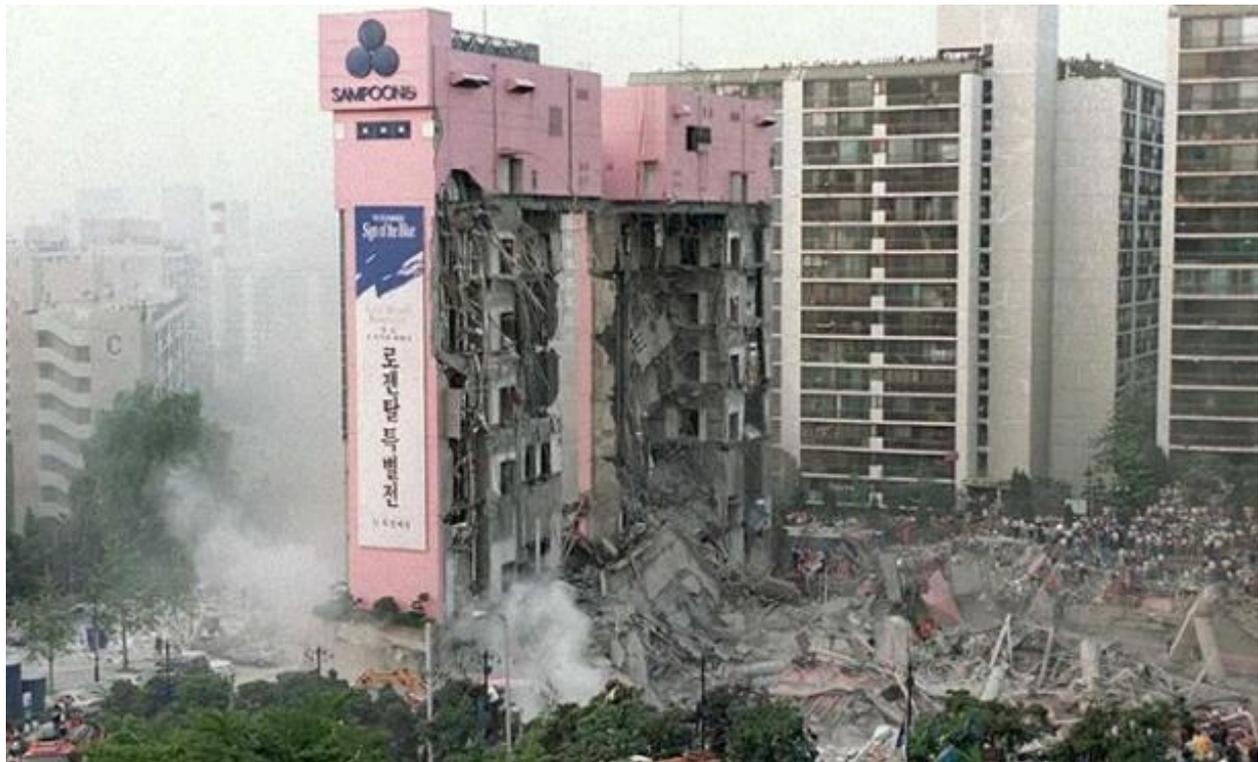
Figure 1. Sampoong Department Store, South Korea

The completed building was a flat-slab structure, without crossbeams or a steel skeleton, which effectively meant that there was no way to transfer the load across the floors. To maximize the floor space, Lee Joon ordered the floor columns to be reduced to be 24 inches (61 cm) thick, instead of the minimum of 31 inches (79 cm) in the original blueprint that was required for the building to stand safely. In addition, each column was 36 feet (11 m) apart to maximize retail space, a decision that also meant that there was more load on each column than there would have been if the columns were closer together.

In addition, the building's air conditioning unit was also installed on the roof, creating a 45-tonne (50-ton) load that was four times the design limit. In 1993, the air conditioning units were dragged across the delicate roof, where the cracking started. The units were moved over the column 5E, where the most visible cracks in the floor of the fifth level were seen before the collapse. The cracks in the columns worsened because the columns supporting the fifth floor were mismatched with the ones supporting the floors below it.

Around 5:52 p.m., the roof gave way, and the air conditioning units crashed through into the already-overloaded fifth floor. The main columns weakened to allow the insertion of the escalators, collapsed in turn, and the building's south wing pancaked into the basement. Within 20 seconds of the disaster, all of the building's columns in the south wing gave way, killing 502 people and trapping more than 1,500 inside.

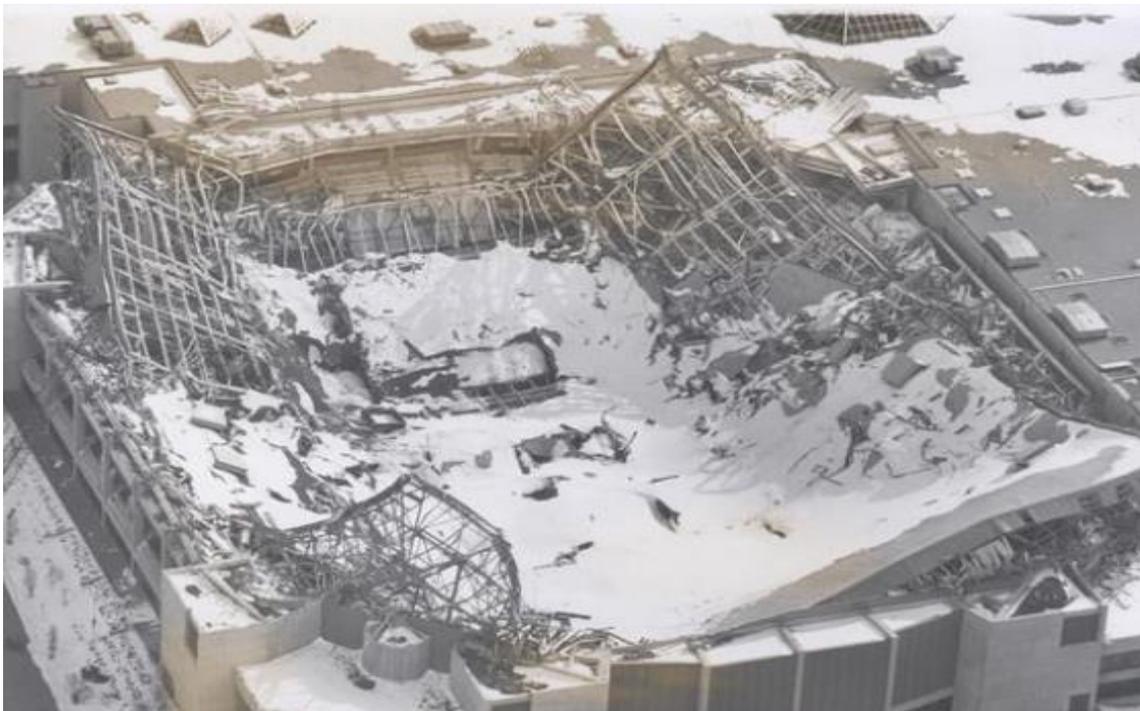
Figure 3. Katowice Trade Hall, Poland

The roof of one of the buildings at the Katowice International Fair collapsed in Chorzów / Katowice, Poland [6]. The central section of the roof of the hall collapsed, possibly due to the weight of snow on the building. According to the police, there were roughly 700 people in the hall at the time of the collapse. A forensic investigation found numerous design and construction flaws that contributed to the speed of the collapse. The snow from the roof was not being removed which resulted in construction overload by more than 100%. In 2002, the construction buckled under the heavy snow; contrary to the regulations the hall was repaired without getting a building inspector's clearance and without doing necessary tests and calculations to determine if the construction was stable and had sufficient strength.

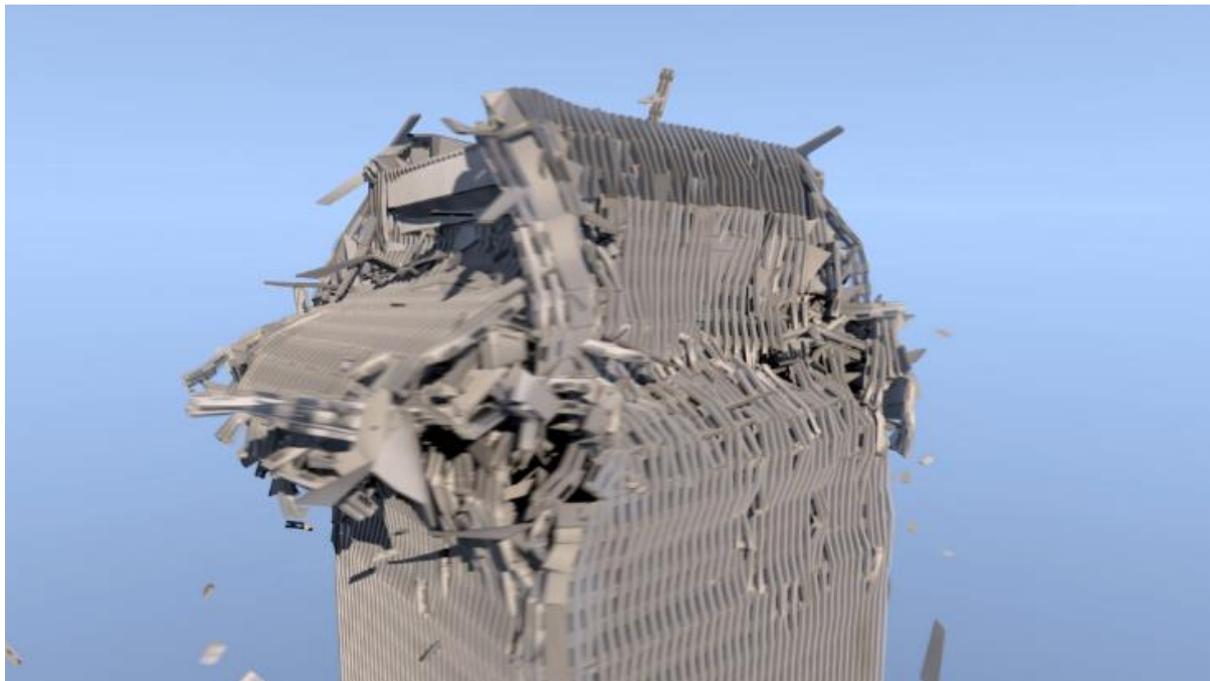
Figure 4. World Trade Center, USA

The cause of the tower's collapse is that the high temperatures in the fires weakened the steel beams and columns, causing them to become "soft and mushy", and eventually were unable to support the structure above. The fireproofing became dislodged during the initial aircraft impacts. The initial structural failure occurred; the progressive collapse of the entire structure was inevitable. The heat from the fires was a key factor, causing steel columns in both the core and the perimeter to weaken and experience deformation before losing their carrying capacity and buckling. Once more than half of the columns on a particular floor buckled, the overhead structure could no longer be supported and complete collapse of the structures occurred. Bažant later published an expanded version of this analysis [10,11].

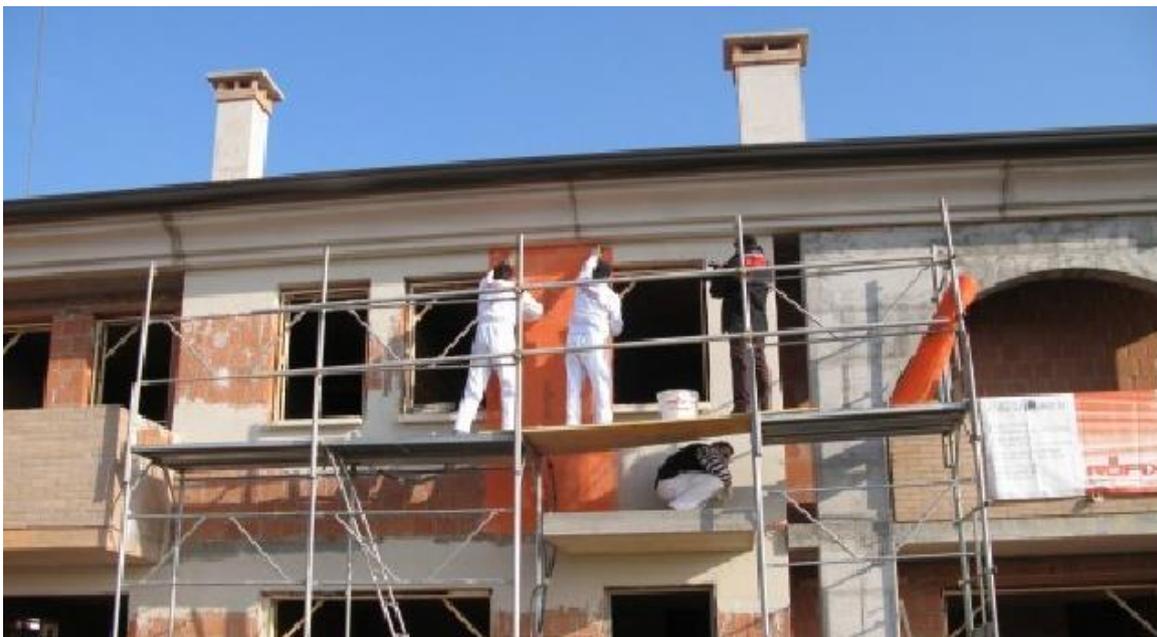
Figure 6. Preventing structural collapse with wallpaper

A competent person should inspect the temporary bracing arrangements and verify in writing the stability of the structure when the bracing is first installed. A competent person should regularly assess the stability of the structure while temporary bracing is required. Inspections should be done at regular intervals, based on a risk assessment that takes into account the structure's condition, environmental factors and length of time the bracing has been in place. In addition, an inspection should occur as soon as possible after an extreme weather event or another incident that could affect stability.
