Aluminum and its alloys in the very high cycle fatigue regime

This paper examines the very high cycle fatigue of aluminum alloys used in engineering applications. Specifically taken into consideration are findings of tests and experiments by some scientists and experts in the field of fatigue of structural materials. The examination of the most common material defects that initiate cracks and causes of fatigue failures in aluminum alloys in the very high cycle regime are reviewed. As aluminum alloys are among the most commonly used structural materials that do not exhibit a fatigue limit at 10^7 load cycles, it became very important to critically review the tests and experiments of experts in the field in order to ascertain the most causes of failures in these alloys. This paper concluded by suggesting the directions for future works in the very high cycle fatigue of aluminum alloys based on the theoretical review.

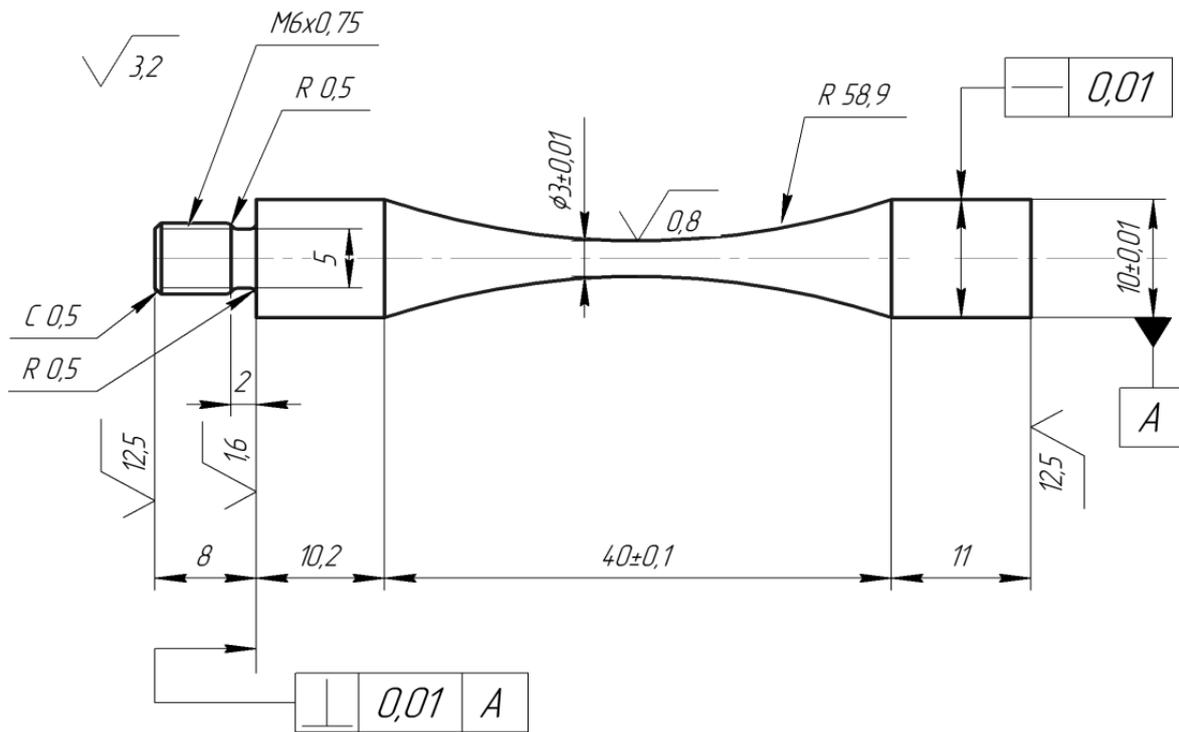
Fig. 1. Aluminum specimen sample for ultrasonic fatigue testing [3]

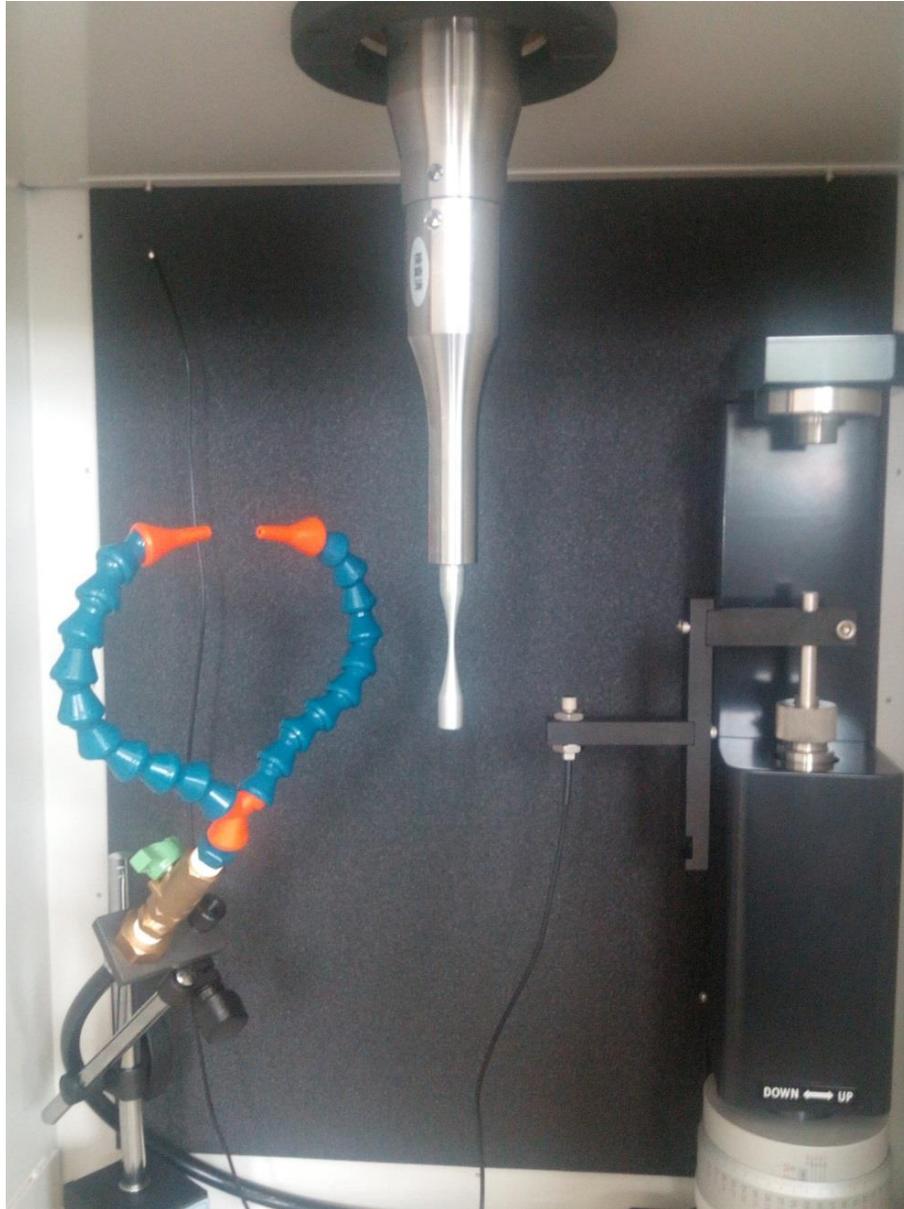
Fig. 2. Aluminum specimen sample screwed to the horn of SHIMADZU ultrasonic fatigue testing machine (USF-2000)

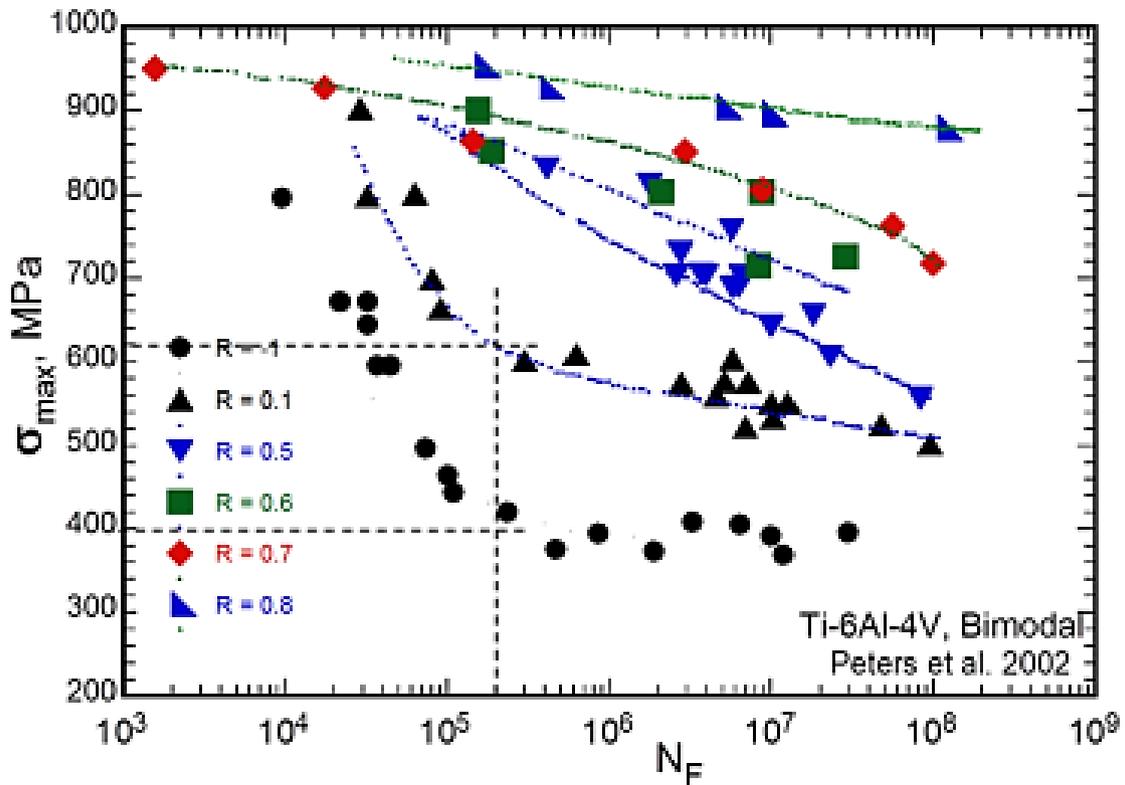
Fig. 3. S-N data for Ti-6Al-4V alloy plotted in terms of σ_{max} vs. the number of cycles to fail for various constant R-ratios [8]

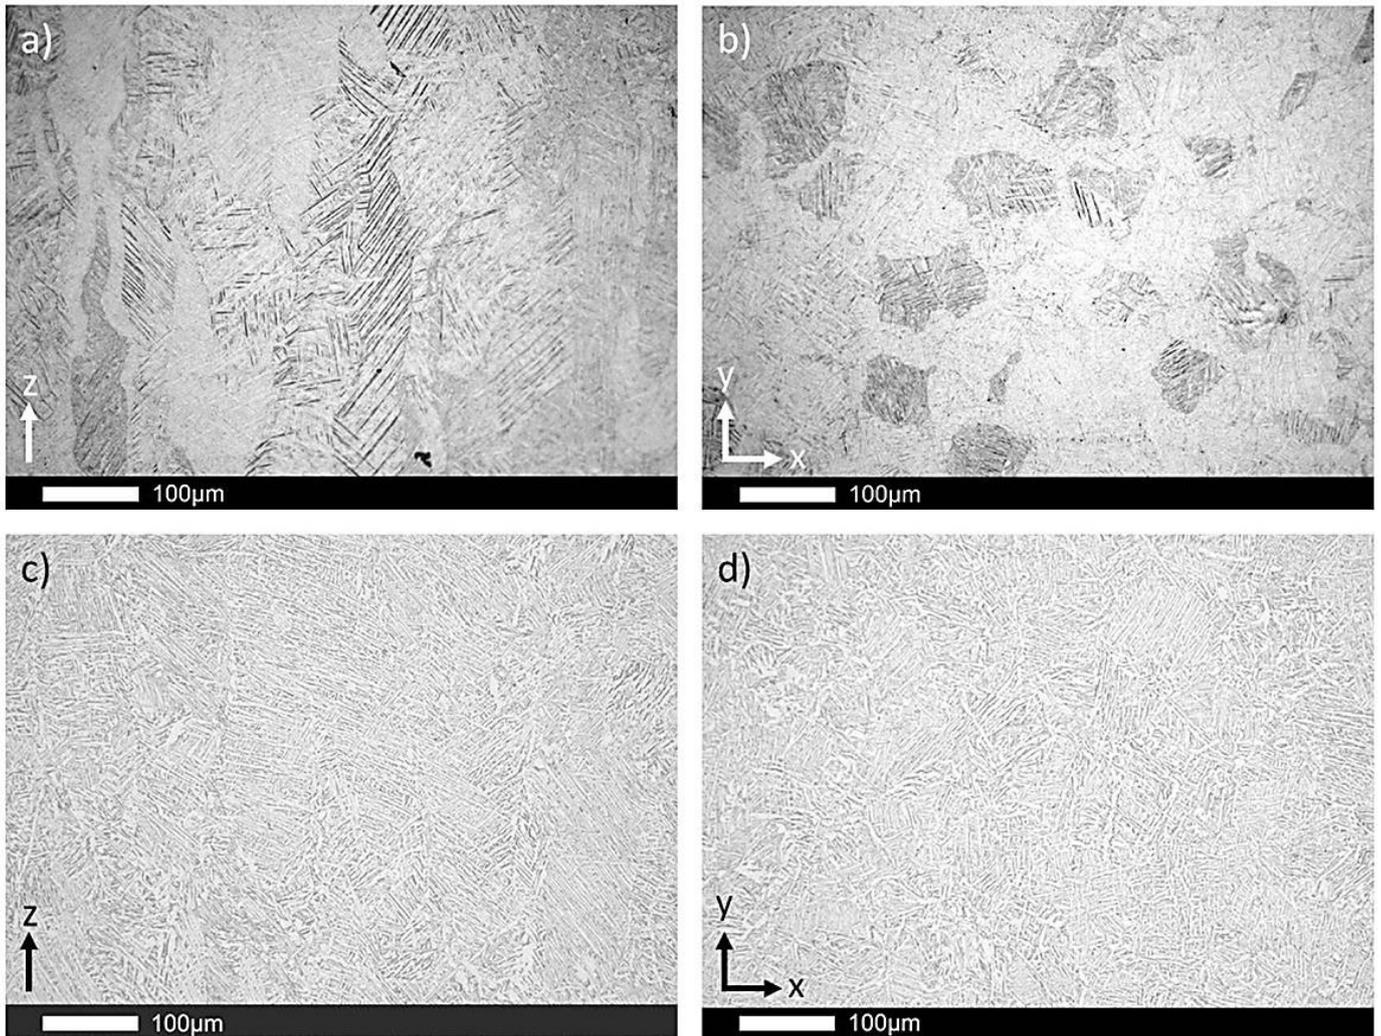
Fig. 4. Microstructure of laser additive manufactured Ti-6Al-4V in stress-relieved (A,B) and hot-isostatic-pressed (C,D) condition. [12]

Wycisk et al. [12] after conducting tests on the fatigue properties of laser additive manufactured Ti-6Al-4V under cyclic tension-tension until 10^7 cycles and tension-compression load until 10^9 cycles were able to reveal that process inherent defects have a major influence on the fatigue performance of laser additive manufactured Ti-6Al-4V. They showed that regardless of the applied load ratio, all specimens fail due to crack initiation at process inherent defects, and that depending on the size and location of the defect, the lifetime to failure can vary greatly. They suggested that post treatment by hot-isostatic-pressing cures process inherent defects, improves the fatigue performance significantly. Crack initiation at defects can no longer be observed.

Another interesting conclusion they made was that testing until 10^9 cycles showed no conventional fatigue limit but decreasing fatigue strength with increasing fatigue life for stress-relieved and hot-isostatic-pressed material and that an influence of test frequency on fatigue life could not be observed.
