Use of Forensic Engineering for Abandoned Building

Tomas U. Ganiron Jr.

This descriptive study focused on the forensic investigation of abandoned Government Service Insurance System (GSIS) building in Manila. The post-fire investigation was conducted on structural elements in order to ascertain their in situ residual strengths and also to provide data for use in future assessment. Tests were conducted on beams, columns, and slabs in both the affected and the unaffected parts of the buildings. From the results, visual examination of the fire-affected buildings revealed that the steel corrosion and concrete deterioration are the major factors that affected the stability and integrity of structural members of the abandoned GSIS building in Manila. There was a notable reduction in the in situ strengths of the fire-affected structural members when compared with the unaffected members. However, the abandoned GSIS building is still in serviceable condition in terms of its structural members

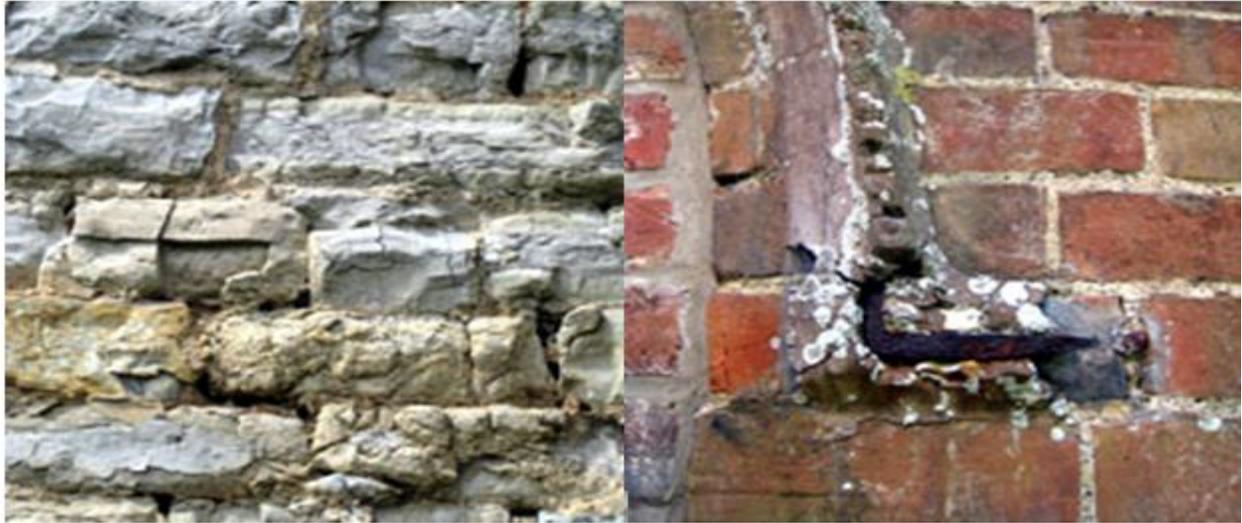
The most common failures in building fabric can usually be traced back to one of three basic causes (Mosquera et al., 2002). These are poor construction, inappropriate repair or neglect. Although it is tempting to imagine that all old buildings were soundly and robustly built this is not necessarily true. Medieval structures may not have foundations in the sense that would think of them whilst Georgian or Victorian buildings might have an outer face of stone tied back to the structure with iron cramps, which are susceptible to rust.

Figure 6. Poor construction

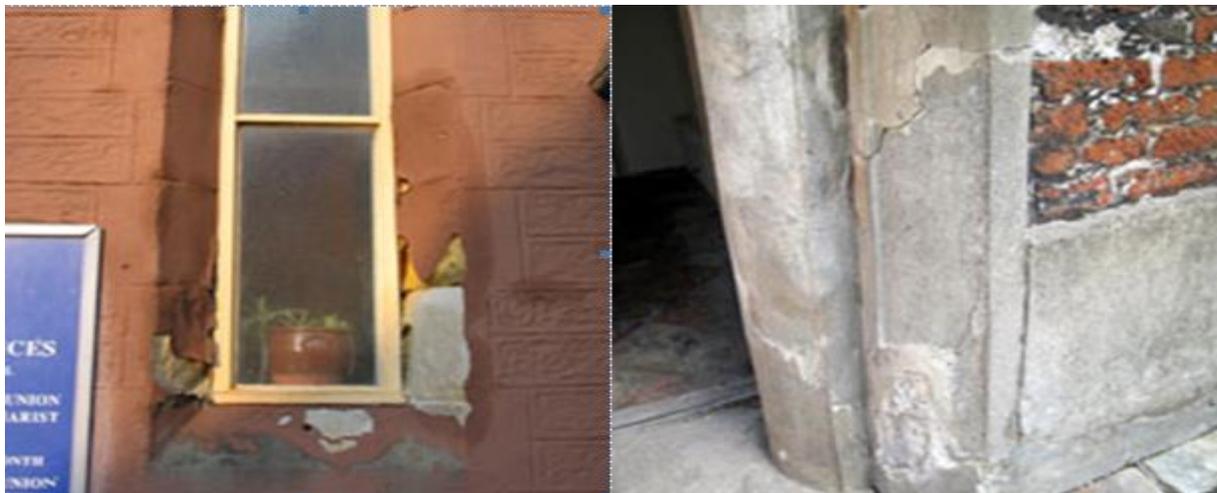
The issue of inappropriate repairs frequently crops up when dealing with historic buildings. One of the most common is the use of modern cement mortar to repaint old walls. Whilst walls do need to be repainted from time to time to protect them from the weather, using a cement mortar is likely to increase the rate of decay and cause a great deal of damage (Ucol-Ganiron Jr, 2012). Such work is usually carried out with the best of intentions but is ultimately harmful to the building fabric. In such a case, it would have been better to seek professional advice about the specification for the repointing works and appoint a contractor familiar with traditional lime mortars. Other examples are the use of chemically injected damp proof courses or the application of proprietary water repellent solutions or modern emulsion paints to old walls (Van Hees, 2001). Such products will often prevent the proper evaporation of moisture from the wall and can exacerbate any inherent problems of dampness.

Figure 7. Inappropriate repair
